November 2010

CIVIL ENGINEERING JOURNAL

CORRELATED CHARACTERISTICS OF TERMITES ATTACK WITH HIGH-RISE BUILDING CONDITION INDEX

James Rilatupa¹

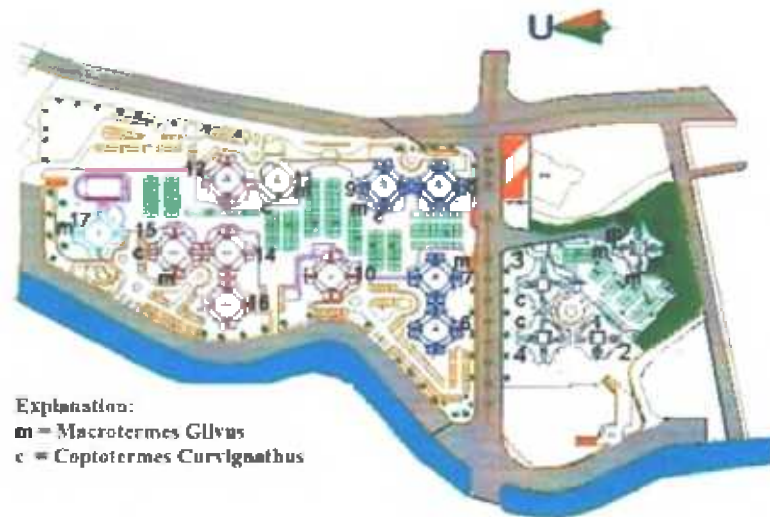
Figure 1. The apartments and hotels in South Jakarta and the mapping of termites

This research showed that the species of termite exist in the apartments and hotels are *Macrotermes Gilvus* and *Coptotermes Curvignathus*. *Macrotermes Gilvus* termites exist in the area around Building 1, 7, 9, 11, 15, and 17. Meanwhile, the *Coptotermes Curvignathus* termites were detected in the surrounding area of Building 1, 2, 3, 4, 9, 11, and 15. Both termite species were found on the areas around Building 1, 9, 11, and 15 whereas in area of Building 6, 8, 10, 12, 14, and 16 termite colonies weren't found.
